**COMPREHENSIVE MOTOR VEHICLE SERVICES AND
CONSULTING
MOTOR VEHICLE FORENSIC ANALYSIS
REPORT**

CMVSC-18-IA-245

-- In the Matter of the Death of Edson Thevenin --

INVOLVED DYNAMIC SUBJECT VEHICLE: 2000 Honda Civic EX Two Door Coupe

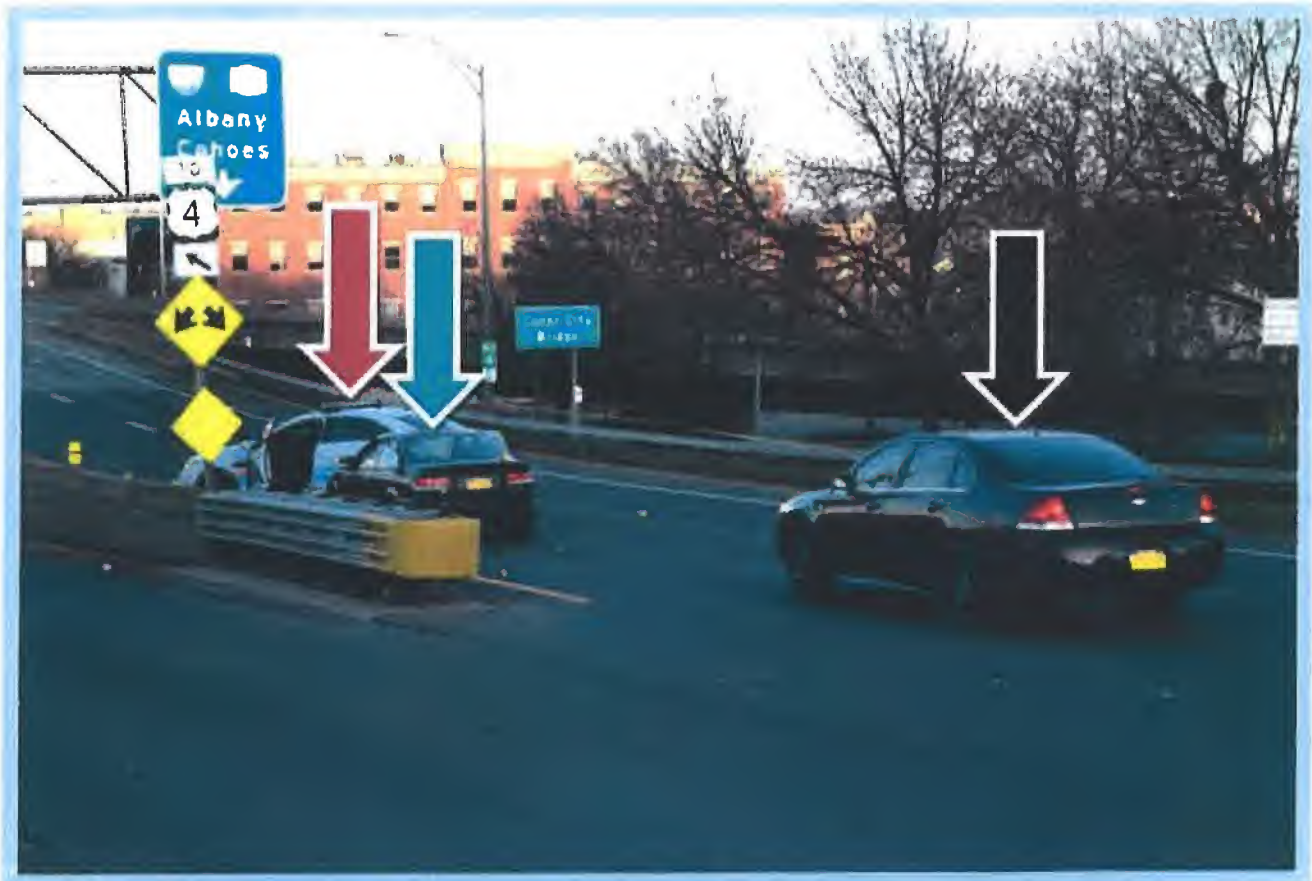
Image No. 1 This photograph, courtesy of the Troy (New York) Police Department, depicts the scene of final rest of the three involved vehicles with respect to the events of April 17, 2016. The Red Arrow denotes the 2011 Ford Taurus police cruiser operated by Troy Police Sergeant Randall French. The Blue Arrow denotes the 2000 Honda Civic operated by Edson Thevenin. The Black Arrow denotes the 2012 Chevrolet Impala police vehicle operated by Troy Police Captain Matthew Monahan, which had been moved rearward from its actual final rest location.

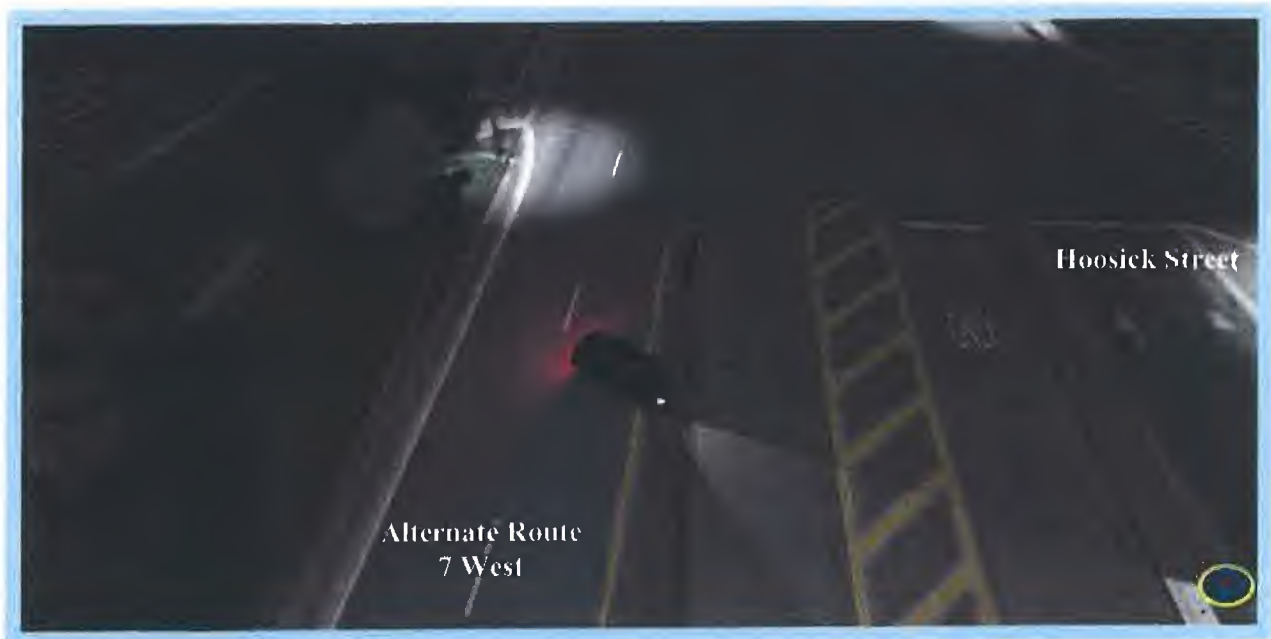
The impact of the westbound 2000 Honda Civic into the concrete median barrier system occurred at an approximate angle of 118 degrees, as determined by and through digital tram assessment of the sustained contact and structural damage at the left front section of the Honda Civic.³

Image No. 4. This 3D Forensic Animation Still Image depicts the approximate initial concrete barrier impact location of the 2000 Honda Civic operated by Edison Thevenin while in a westerly direction on Alternate Route 7 (Cedar City Bridge) after negotiating a u-turn from Hoosick Street. This Computer generated image was created by utilizing forensic scene mapping data, scene photographs, involved vehicle photographs, and forensic damage analyses of the involved 2000 Honda Civic.

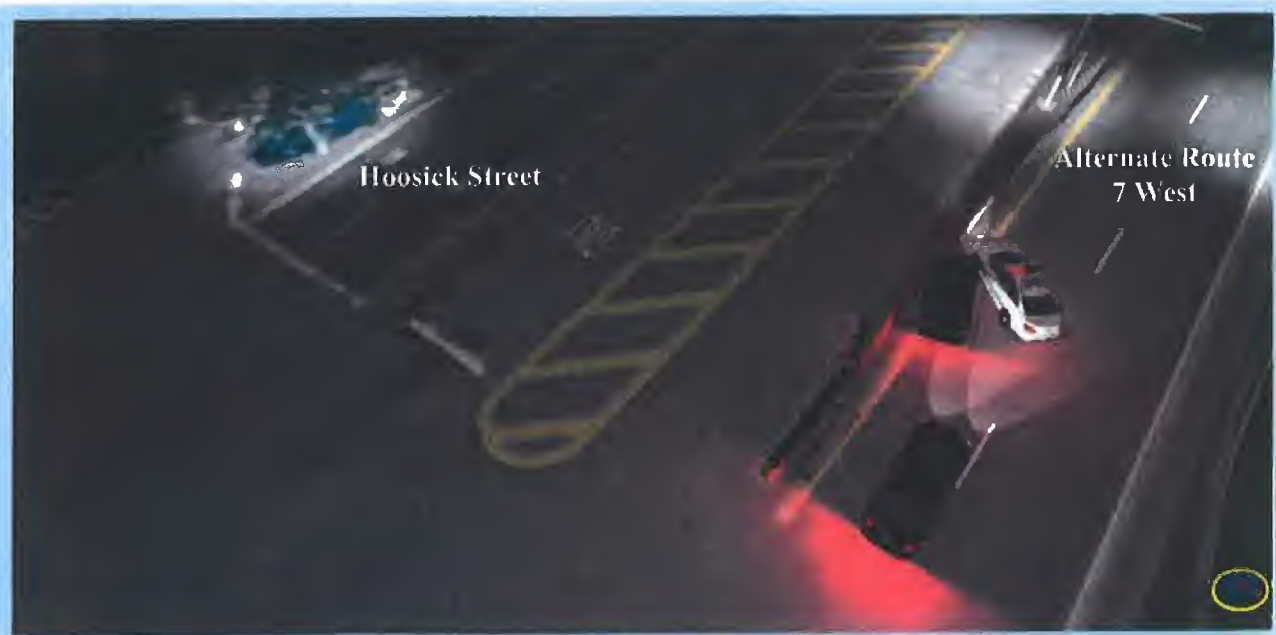
Due to the intensity of the impact of the 2000 Honda Civic operated by Edson Thevenin with the concrete barrier, as well as the approximate 118 degree angle of impact, the left frontal area of the vehicle was propelled into a forced westerly concrete barrier slide of approximately fifty-one (51) inches. This clockwise rotation of the 2000 Honda was substantiated by 1) concrete barrier evidence; 2) roadway right front Honda tire scuff mark; and 3) Honda physical crash evidence. (Also see Image No. 46, Page 61.)

Image No. 5 This 3D Forensic Animation Still Image depicts the approximate final concrete barrier impact location of the 2000 Honda Civic, operated by Edson Thevenin, subsequent to clockwise rotation of the vehicle due to the severity of the impact and angle of approach while in a westerly direction on Alternate Route 7 (Collier City Bridge) after separating a left turn from Hoosick Street. This computer generated image was created by utilizing forensic scene mapping data, scene photographs, involved vehicle photographs, and forensic damage analysis of the involved 2000 Honda Civic.

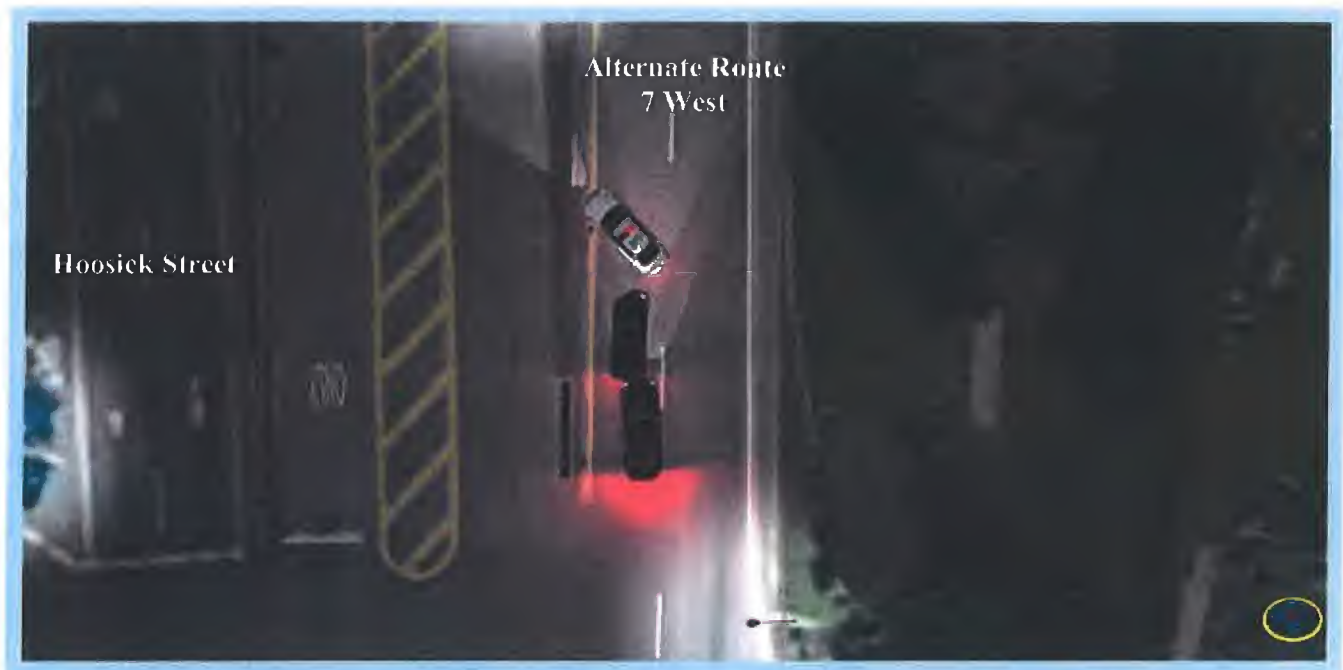
Subsequent to the severe concrete barrier impact and resulting clockwise rotation of the 2000 Honda Civic, and with the two Troy Police Department vehicles on scene as depicted by Image No. 5 (above), Honda operator Edson Thevenin purposefully placed the automatic transmission shifter of the vehicle in the REVERSE position and accelerated rearward, ultimately striking the Troy Police Department 2012 Chevrolet Impala operated by Troy Police Captain Matthew Montanino. Analysis of the physical damage of the two motor vehicles reveals that impact occurred between the right rear bumper cover of the 2000 Honda Civic and the left center bumper cover of the 2012 Chevrolet Impala.

Image No. 6: This 3D Forensic Animation Still Image depicts the approximate location of the 2000 Honda Civic operated by Edson Thevenin at impact with the Troy Police Department 2012 Chevrolet Impala after backing from concrete barrier final impact location on Alternate Route 7 (Cullen City Bridge). This computer generated image was created by utilizing forensic scene mapping data, scene photographs, involved vehicle photographs, and forensic damage analysis of the involved 2000 Honda Civic and 2012 Chevrolet Impala.

(Off note is the distance of approximately thirty-nine (39) inches between the right front bumper of the 2000 Honda Civic and the left rear wheel area of the marked Troy Police Department 2012 Ford Faurus owned by Troy Police Sergeant Randall French.

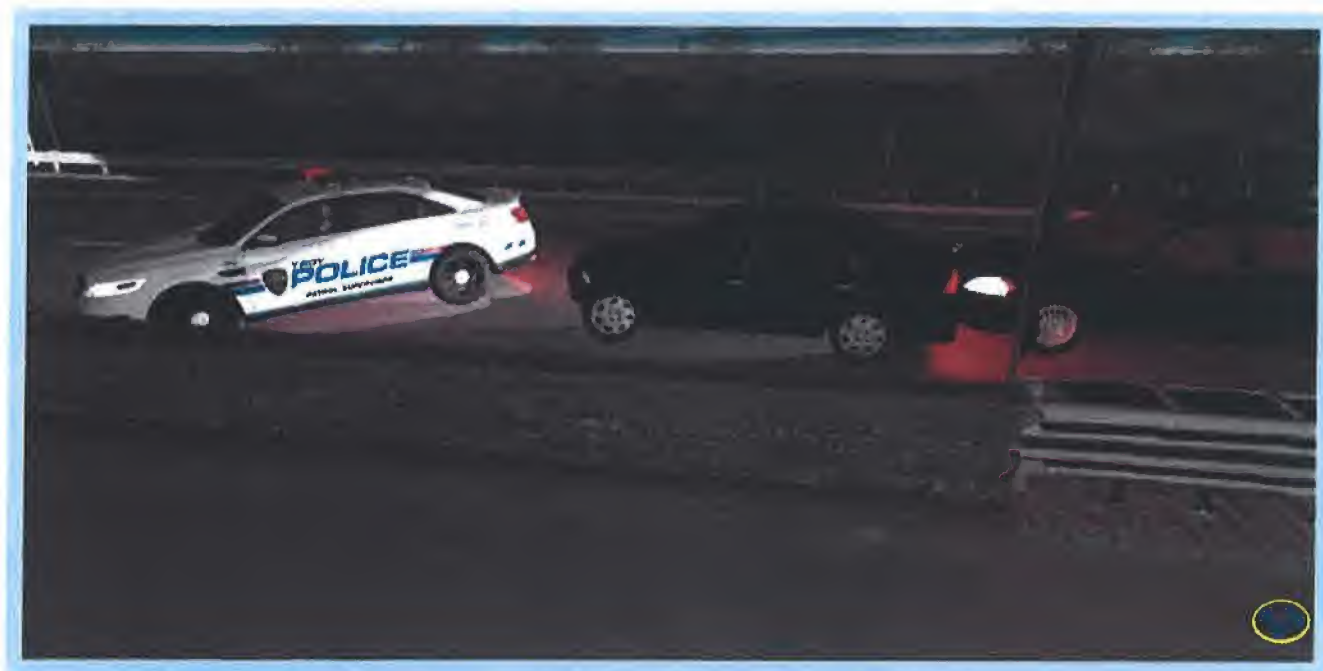
Image No. 66 This 3D Forensic Animation Still Image depicts the Hirsch Street view of the approximate location of the 2000 Honda Civic operated by Edson Thevenin at impact with the Troy Police Department 2012 Chevrolet Impala after banking from concrete barrier fence impact location on Alternate Route 7 (Collar City Bridge). This computer generated image was created by utilizing forensic scene mapping data, scene photographs, involved vehicle photographs, and forensic damage analyses of the involved 2000 Honda Civic and 2012 Chevrolet Impala.

Of note is the distance of approximately thirty-nine (39) inches between the right front bumper of the 2000 Honda Civic and the left rear wheel area of the marked Troy Police Department 2012 Ford Taurus operated by Troy Police Sergeant Randall Farrell.

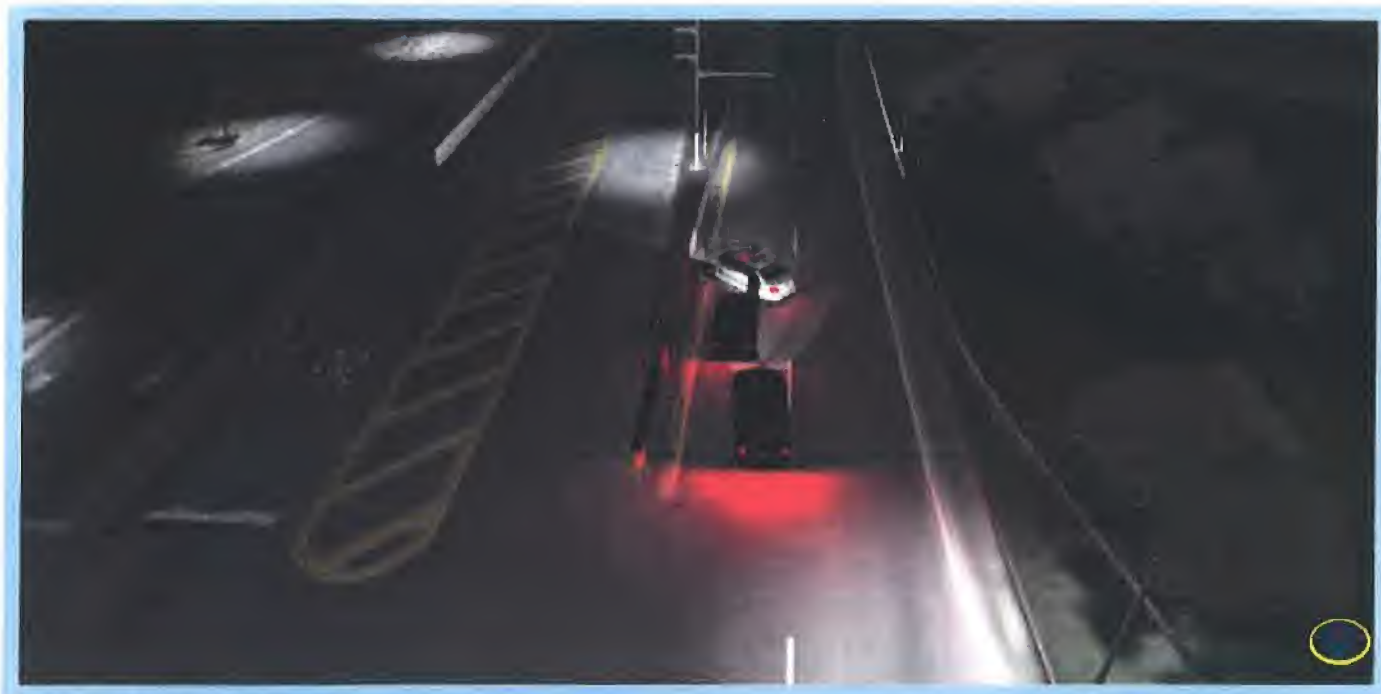
approximately thirty-nine (39) inches to impact with Troy Police Sergeant Randall French, who had exited the driver seat and was positioned in the proximity of the left rear quarter panel of the marked Troy Police Department 2013 Ford Taurus.

Image No. 7a This 3D Forensic Animation Still Image depicts the approximate location of the 2000 Honda Civic, operated by Edson Therman at impact with Troy Police Sergeant Randall French at the left rear quarter panel area of the Troy Police Department 2013 Ford Taurus after having been accelerated a distance of approximately 39 inches in a forward trajectory from the area of previous impact with the Troy Police Department 2012 Chevrolet Impala. This image is that of facing westerly on Alternate Route 7 (Collar City Bridge). This computer-generated image was created by utilizing forensic scene mapping data, scene photographs, involved vehicle photographs, and forensic damage analyses of the involved 2000 Honda Civic.

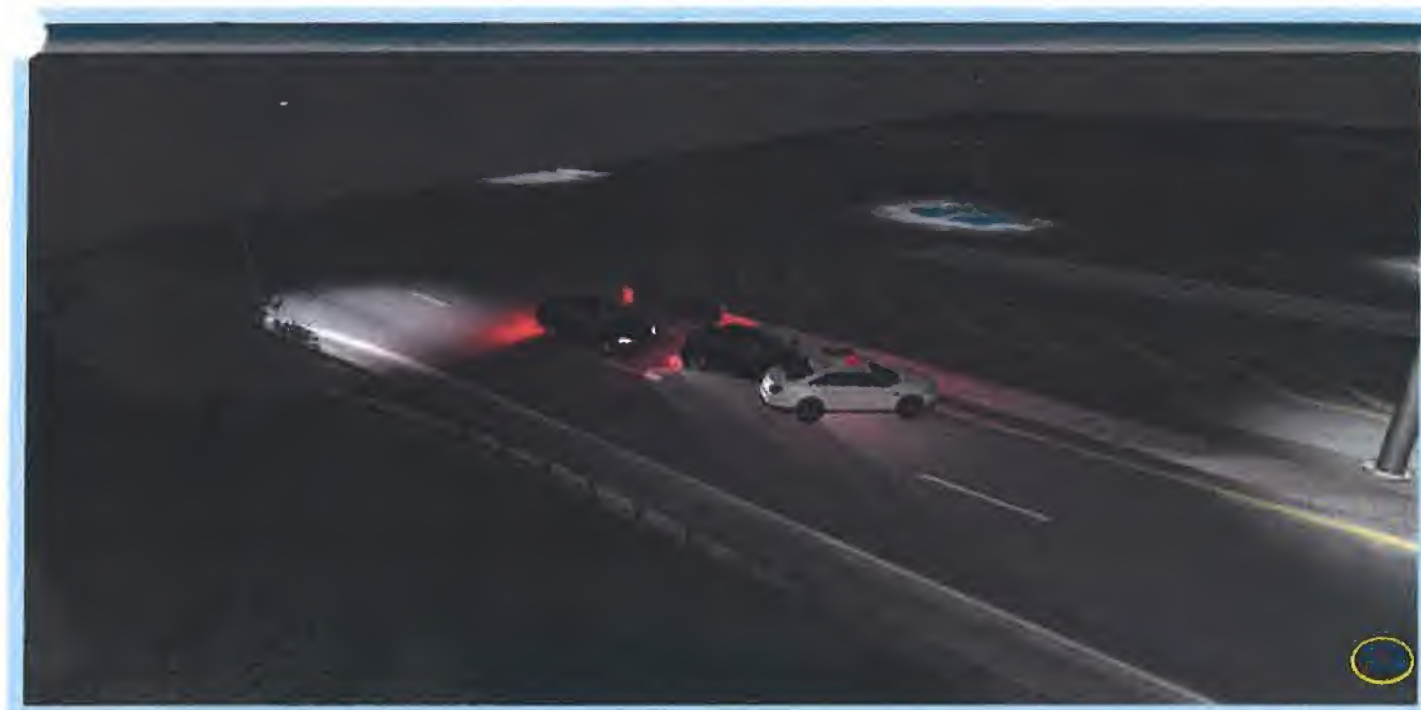
Image No. 7b This 3D Forensic Animation Still Image depicts the approximate location of the 2006 Honda Civic, operated by Edwin Thuermer, at impact with Troy Police Sergeant Randall French as the left rear quarter panel area of the Troy Police Department 2013 Ford Taurus after having been accelerated a distance of approximately 70 inches in a forward trajectory from the area of previous impact with the Troy Police Department 2012 Chevrolet Impala. This image is that of viewing the scene in a southerly direction.

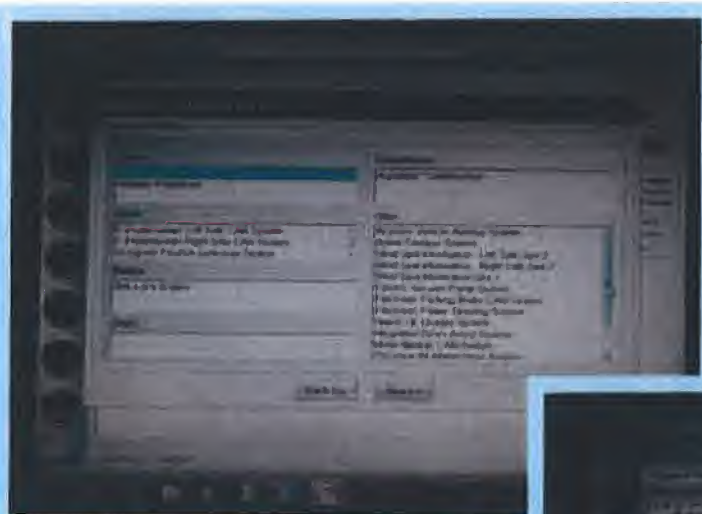
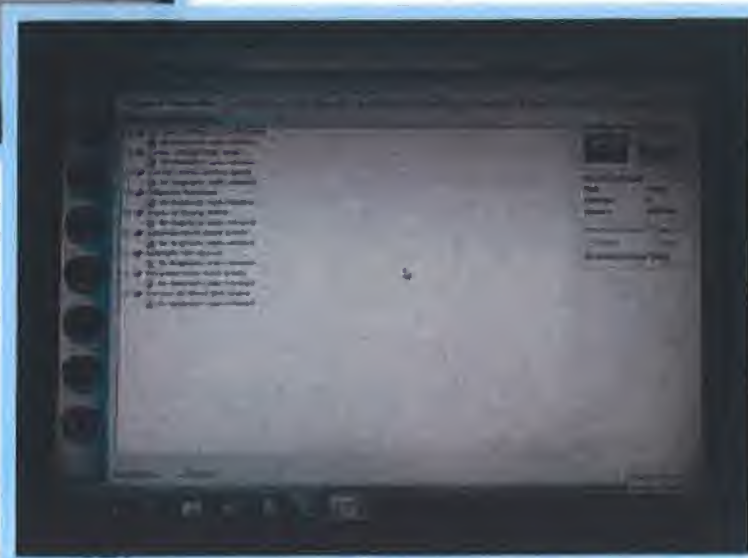
The 2000 Honda Civic EX which is the subject of these forensic analyses was manufactured with numerous computer control systems. As a procedure of the forensic vehicle analyses in this matter, computer serial data communications were initiated to provide both real time and history overview data of the computer control systems. This analysis revealed no faults within any of the computer controlled systems of the vehicle. Mode 02 Data was not recorded at impact.

Images Na 19a & 19b These photographs depict screenshot images of computer serial data communications with the computer control modules of the 2000 Honda Civic. There were no system faults.

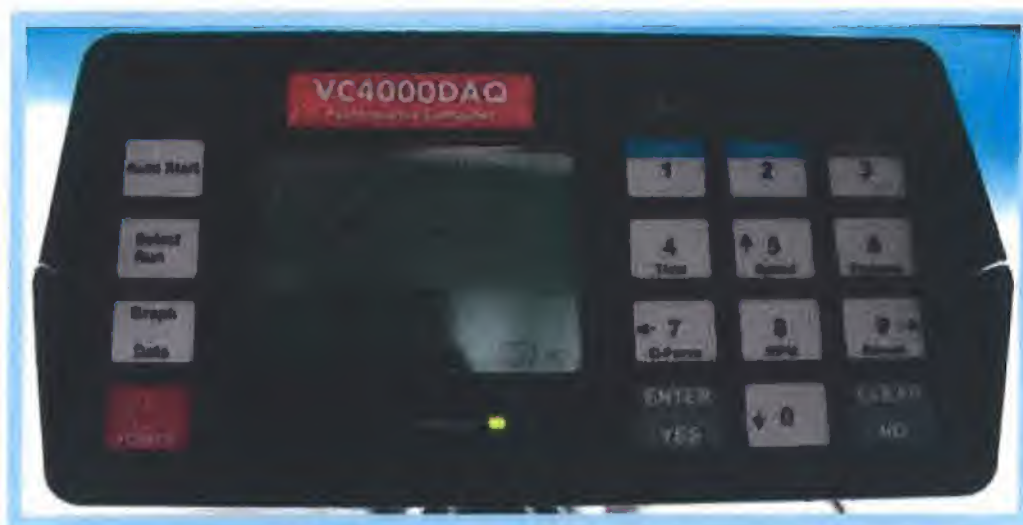
The computer analysis of forward acceleration of the 2000 Honda Civic EX, performed on April 19, 2018 at the Troy Police Department Vehicle Maintenance garage parking lot, revealed that the vehicle accelerated a distance of six (6.0) feet from a stopped position in 2.23 seconds, attaining a speed of 4.8 miles per hour.

Image No. 21 This photograph depicts the Vericom VC4000DAQ computer analyses results of the forward acceleration of the 2000 Honda Civic over a distance of six (6.0) feet from a stopped position.

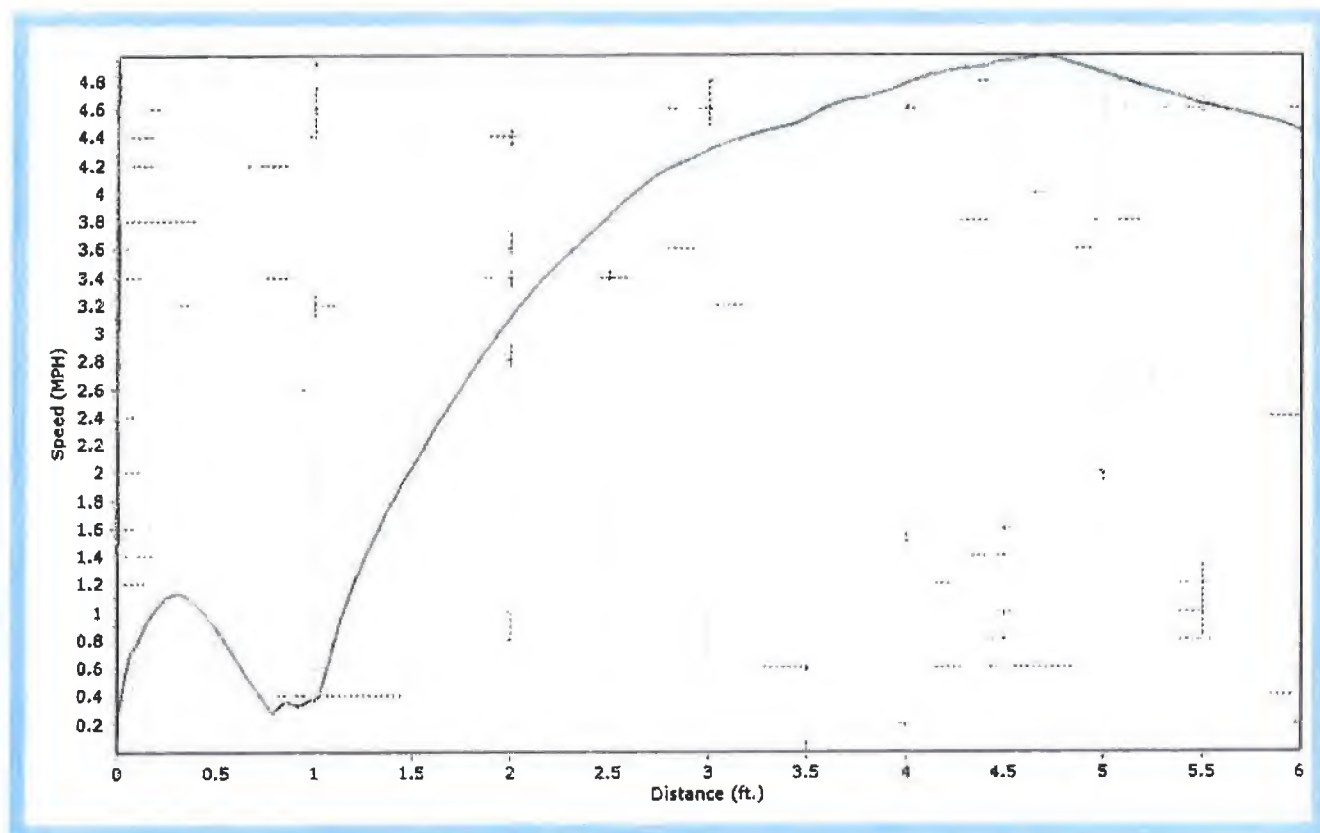
Image No. 22 This graph depicts the Speed of the acceleration of the 2000 Honda Civic in comparison to the Distance of the acceleration of the vehicle. This data and graph were the result of Verivox VT-4000DAQ Computer acceleration analysis.

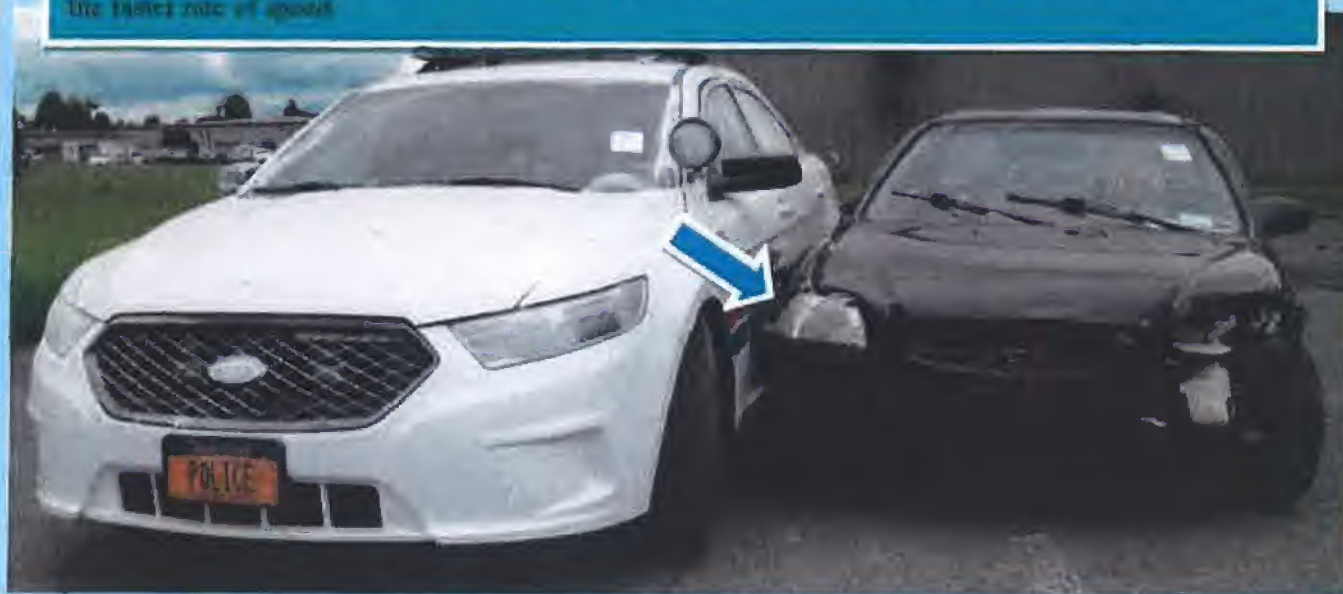
Images No. 42a & 42b These photographs depict the forensic damage matchup of the 2013 Ford Taurus left front door and 2006 Honda Accord right front fender. The blue arrows denote the matched contact areas of the two motor vehicles. The directional damage is consistent with the white Ford Taurus traveling at the faster rate of speed.

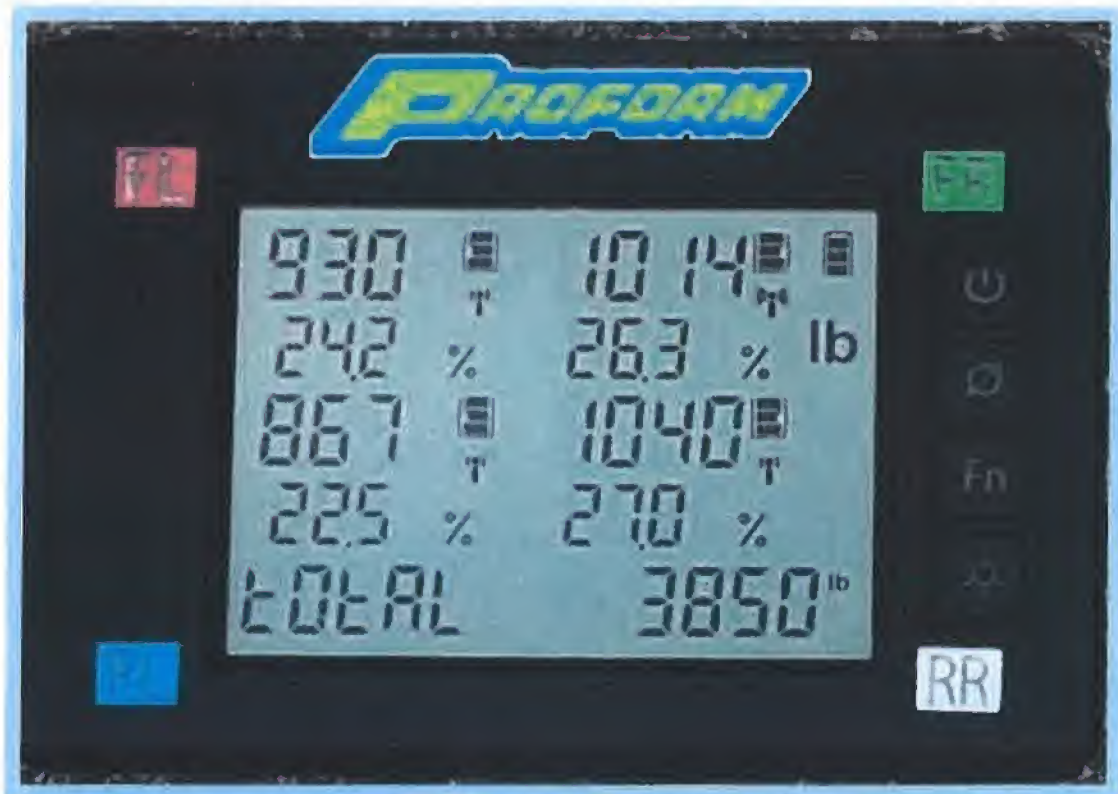
Image No. 44 This photograph represents the results of the weighing of the involved 2013 Ford Taurus. Wireless digital scales were utilized with weighing procedures at all four wheel locations.

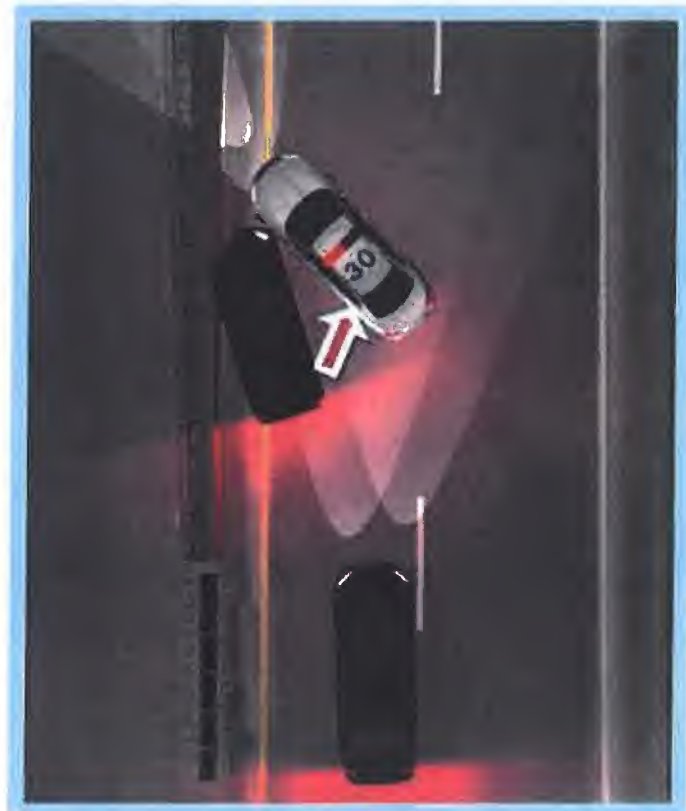
Image No. 45 Based upon physical evidence and forensic scene mapping, the forensic animation still image represents the stopped locations of the involved 2000 Honda Civic and Troy Police Department 2013 Ford Taurus following concrete barrier impact of the 2000 Honda Civic. Given the respective approach angle of the 2013 Ford Taurus, sideswipe contact with the 2000 Honda Civic is not possible. Additionally, the photographically discernible location of the severed right exterior mirror of the Honda (Red Arrow) would not be achievable, as the trajectory of the mirror would be in a direction towards the concrete barrier.

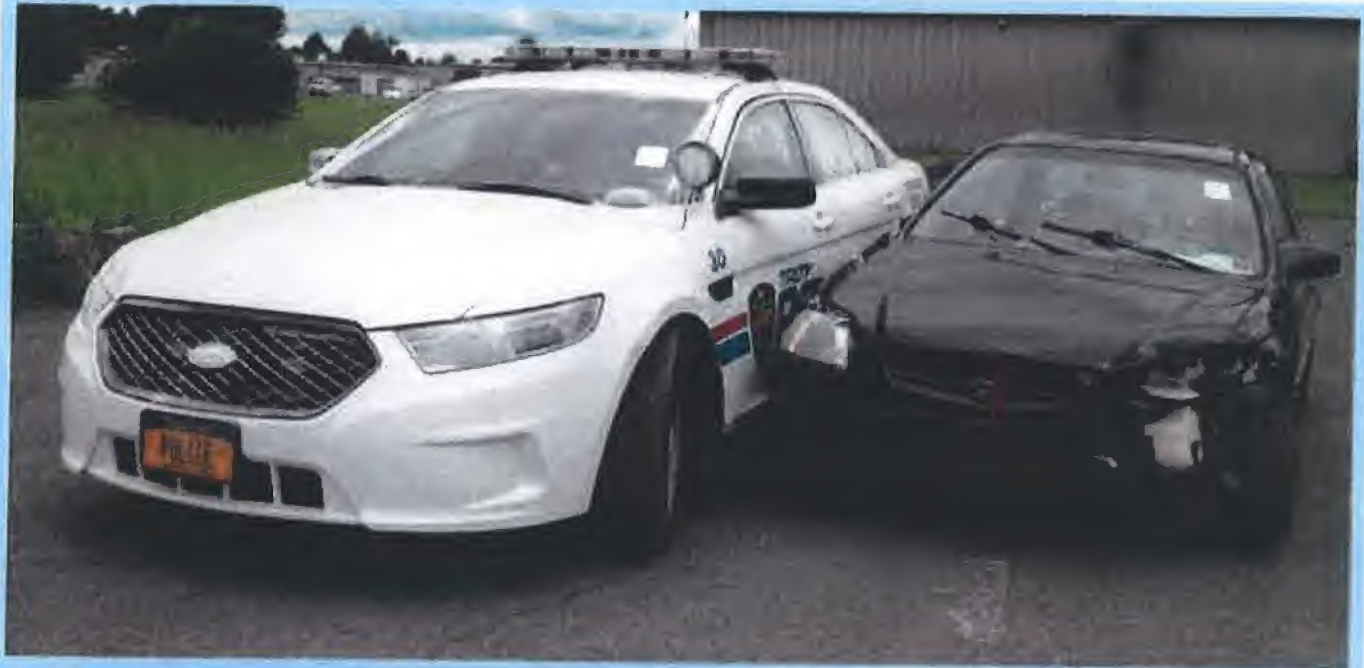
Image No. 47 This photograph, representing the side-by-side impact of the two involved vehicles at the approximate moment of Ford Taurus left from west Honda Civic right from similar common distance standpoint, depicts the comparison of the overall size of the 2013 Ford Taurus (left) and the 2000 Honda Civic (right). Digital scale weighing of the two vehicles revealed that the 2013 Ford Taurus weighed some 1409 lbs. more than the 2000 Honda Civic (without operators).

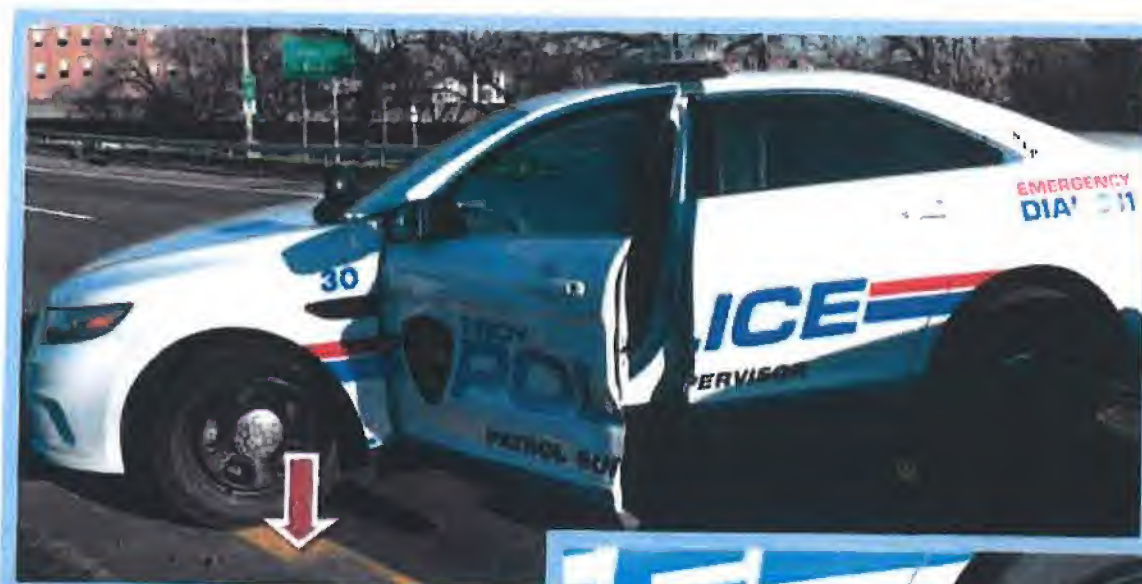
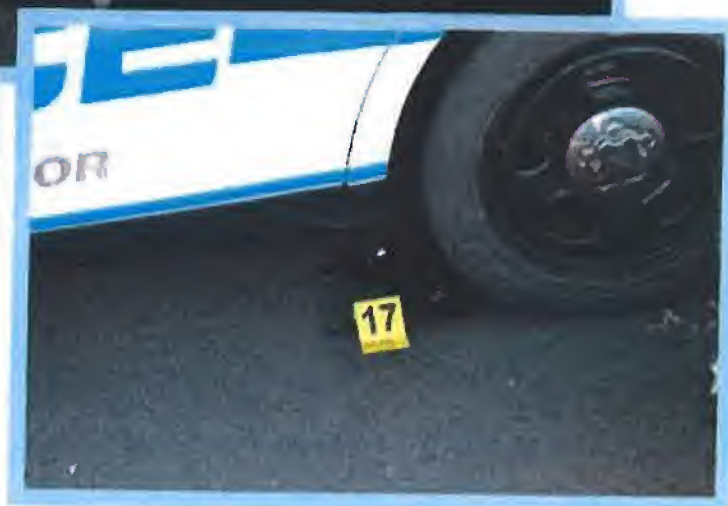
5) The final rest location of the right outside mirror of the 2000 Honda Civic, with physical evidence of forceful severing due to impact by the left front outside door handle of the faster moving 2013 Ford Taurus, is that of a trajectory consistent with the Honda Civic having been impacted in a full sideswipe maneuver as the Honda was operated in a westerly direction on Alternate Route 7 (Collar City Bridge).

Images No. 48a & 48b: These photographs, taken at the scene of the event of April 17, 2016 on Alternate Route 7 (Collar City Bridge) in Troy, New York, depict the final rest location of the severed right exterior mirror of the involved 2000 Honda Civic, operated by Edson Thevenin. There was no evidence that the mirror had been impacted by a vehicle tire, this consistent with the trajectory from impact by the left exterior door handle of the 2013 Ford Taurus. The Red Arrow denotes the previously referenced Honda right front tire scuff mark.

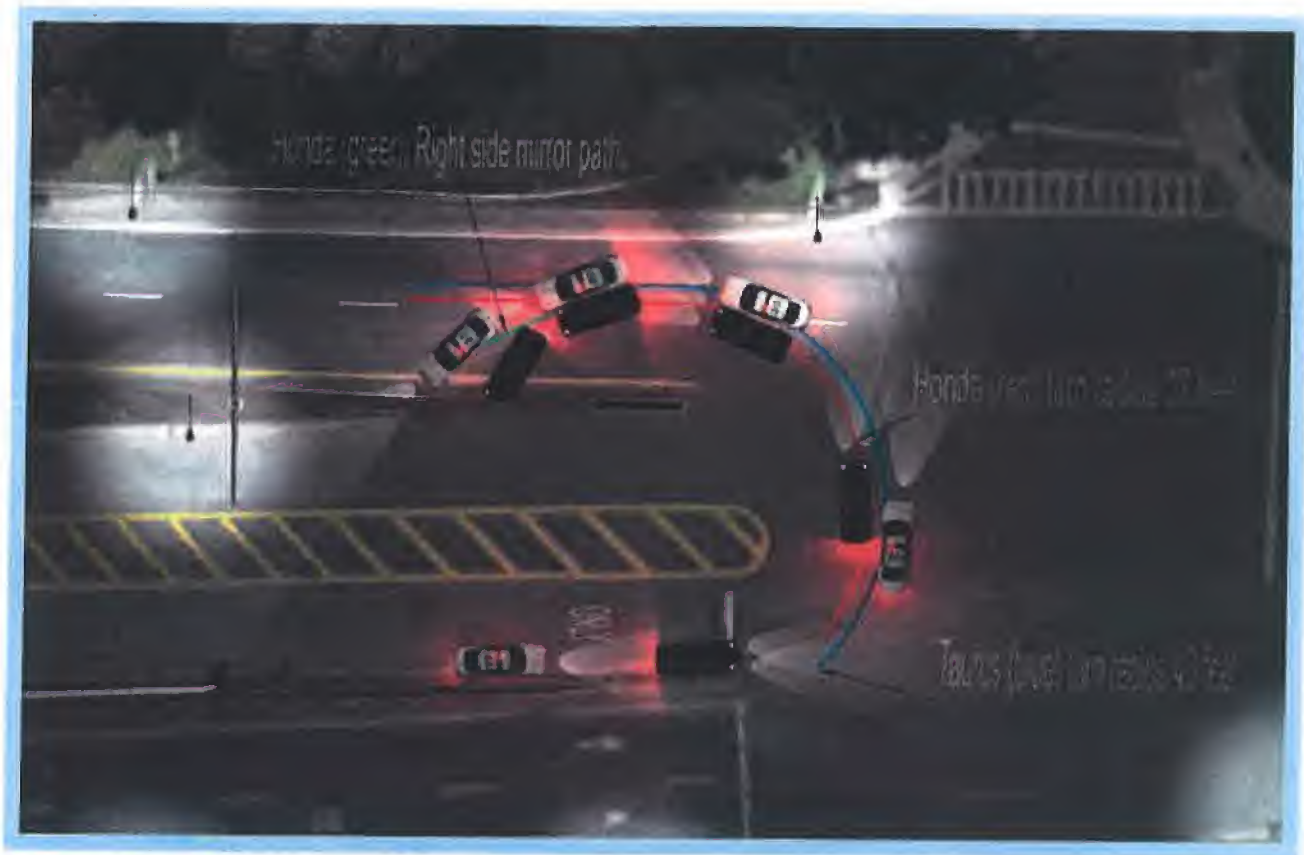
Image No. 49. This 3D forensic still image, created by and through 1) Physical evidence, 2) Scene mapping data, 3) Vehicle turning radius data, 4) Vehicle dimensions, and 5) Forensic science, depicts a scientifically supported scenario with respect to the sideswipe collision of the 2013 Ford Taurus operated by my Police Sergeant Randall French and the 2000 Honda Civic operated by Edison Threventis. (The actual location of impact, vehicle turning radii, and 4-turn locations cannot be accurately established.)

Note the trajectory of the right extreme corner of the 2000 Honda from forceful separation of sideswipe contact to the known location of final rest.
